## **Gas Dynamic Spray Technology Demonstration Project Management**

**Final Joint Test Report  
June 30, 2011**

**Gas Dynamic Spray Technology Demonstration**

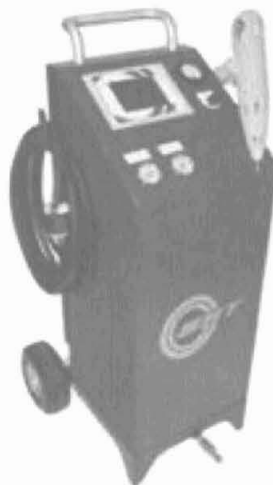
The TSC equipment used for the coating application was a Thermion Bridgemaster powered using a Miller Invision 456 MIG welder (Figure 2). The gas dynamic spray zinc powder was applied using a portable Centerline SST Cold Gas-Dynamic Spray machine, Model Number SSM-P3800-001 (Figure 3).

Figure 3 Centerline SST Cold GDS Machine

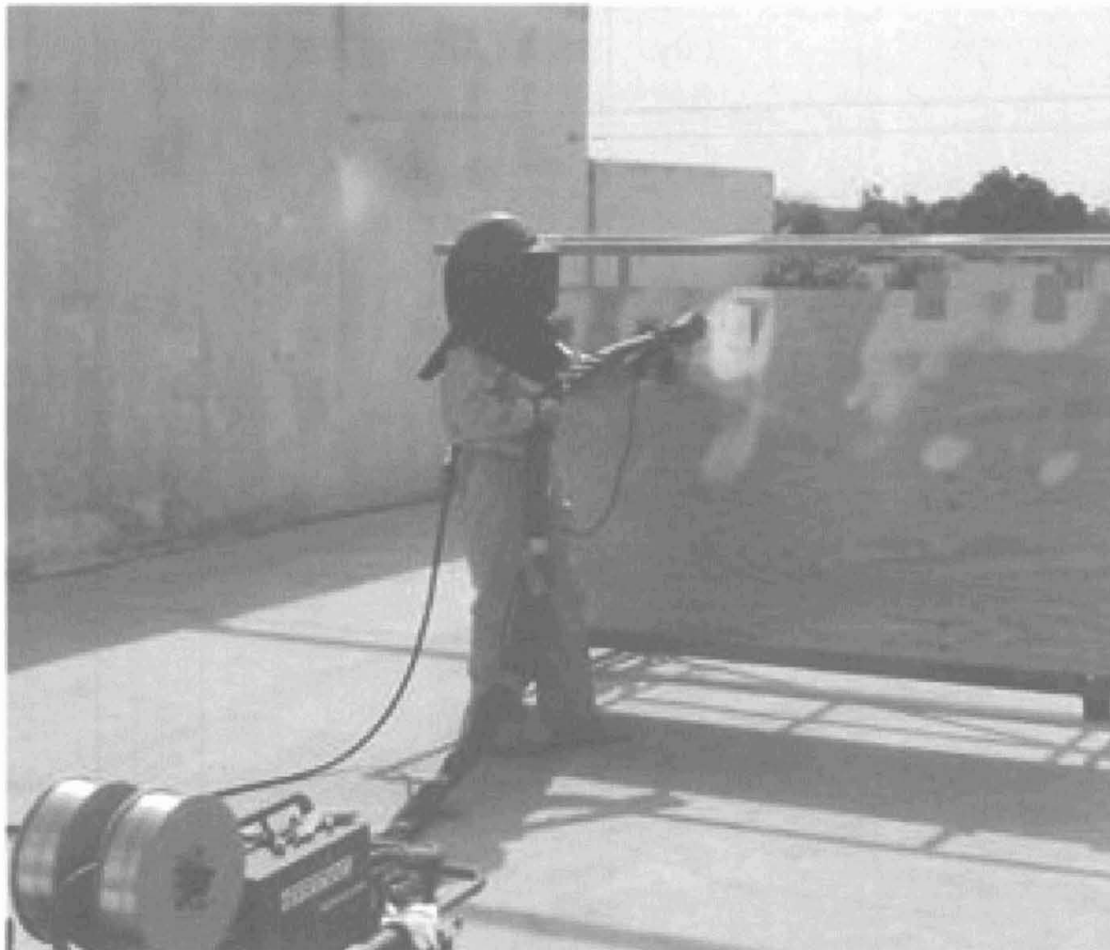
The L3 Corrosion Control Group working out of Patrick Air Force Base (PAFB), FL, provided their services for the TSC (Figure 4) and GDS (Figure 5) applications. Representatives from the NASA Corrosion Technology Laboratory located at Kennedy Space Center (KSC) were present to observe and record the application process.

**Figure 4 Zinc TSC Application**

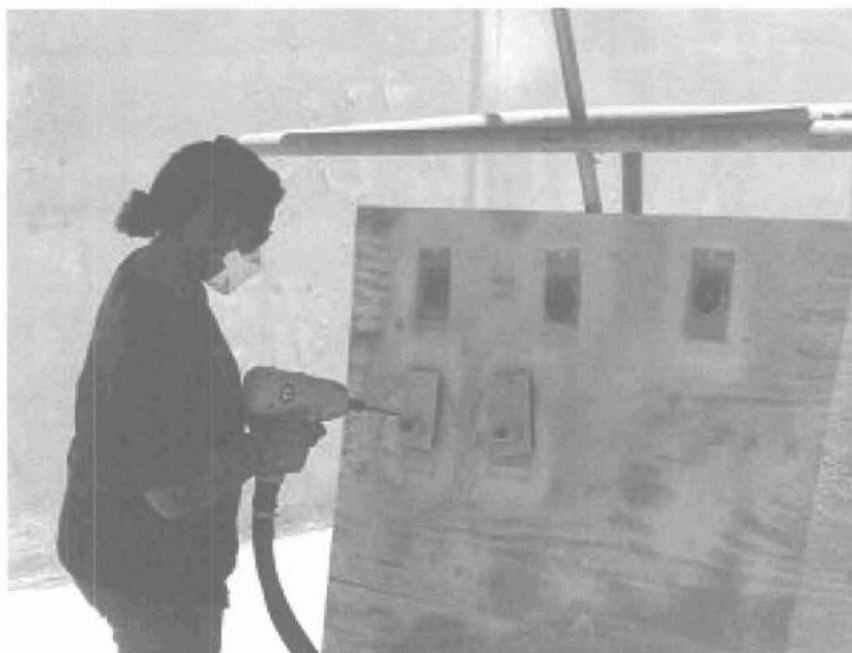
**Figure 5 Zinc GDS Application**

The Zn TSC easily achieved a 10+ mils coating thickness by applying at least three alternate criss-cross patterns with each pass applying three-four (3-4) mils of coating thickness. The Zn GDS coating thickness was achieved by at least eight (8) multiple criss-cross patterns adding one-two (1-2) mils per pass. The spray pattern (~0.5" wide) and amount of overlapping passes took on average five (5) times as long to coat compared to the TSC operation.
